# State of Louisiana Coastal Protection and Restoration Authority

## 2019 Short Summary Report

## Sabine Refuge Marsh Creation Cycles – 3-4-5

State Project Number CS-28  
Priority Project List 8

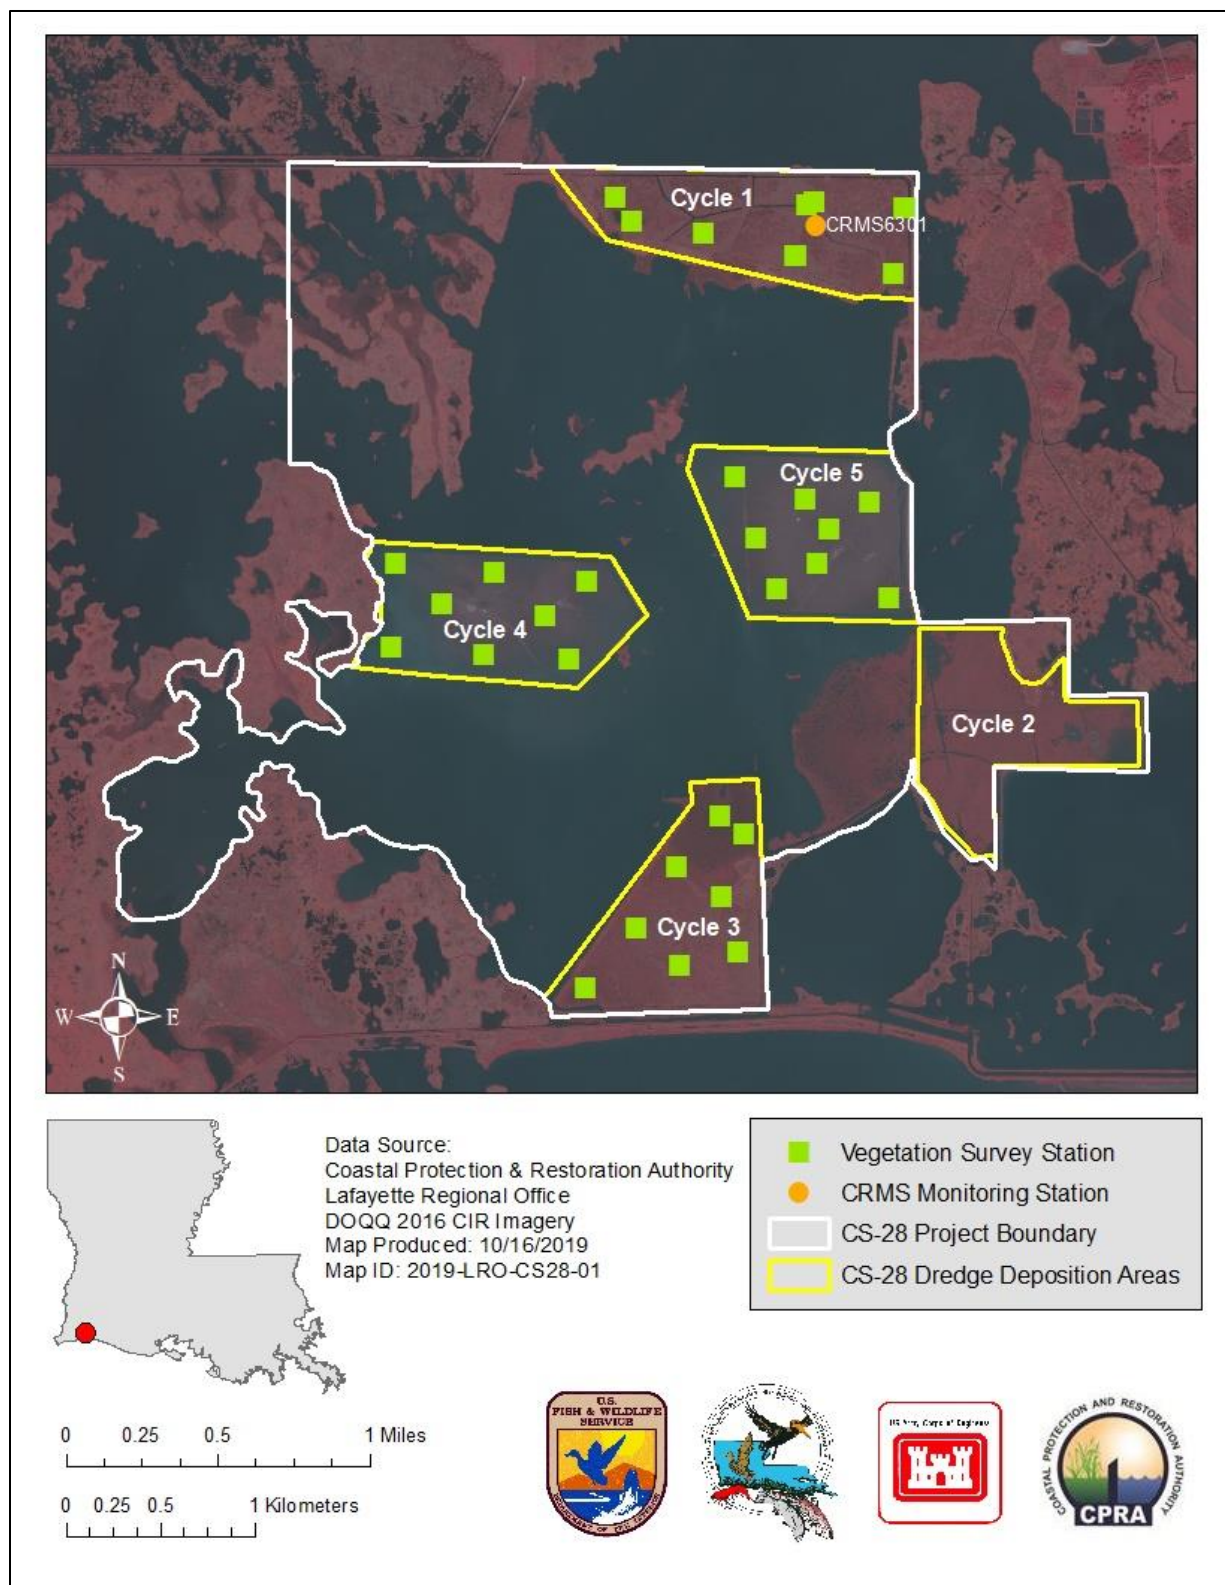
**Figure 1:** Sabine Refuge Marsh Creation (CS-28) project area boundary, deposition area boundaries, vegetation monitoring stations, and CRMS site.

In Cycle 3, eight vegetation stations were established in 2008 and were monitored in 2010, 2012 and 2018. In Cycles 4 and 5 eight vegetation stations were established in 2018 and were monitored in 2018. Two 2 m<sup>2</sup> plots were sampled at each of the stations. Percent cover, height of dominant species, and species richness were quantified. Ten reference stations were established in the pre-existing, reference marshes in the northwest corner of the project area (Figure 1).

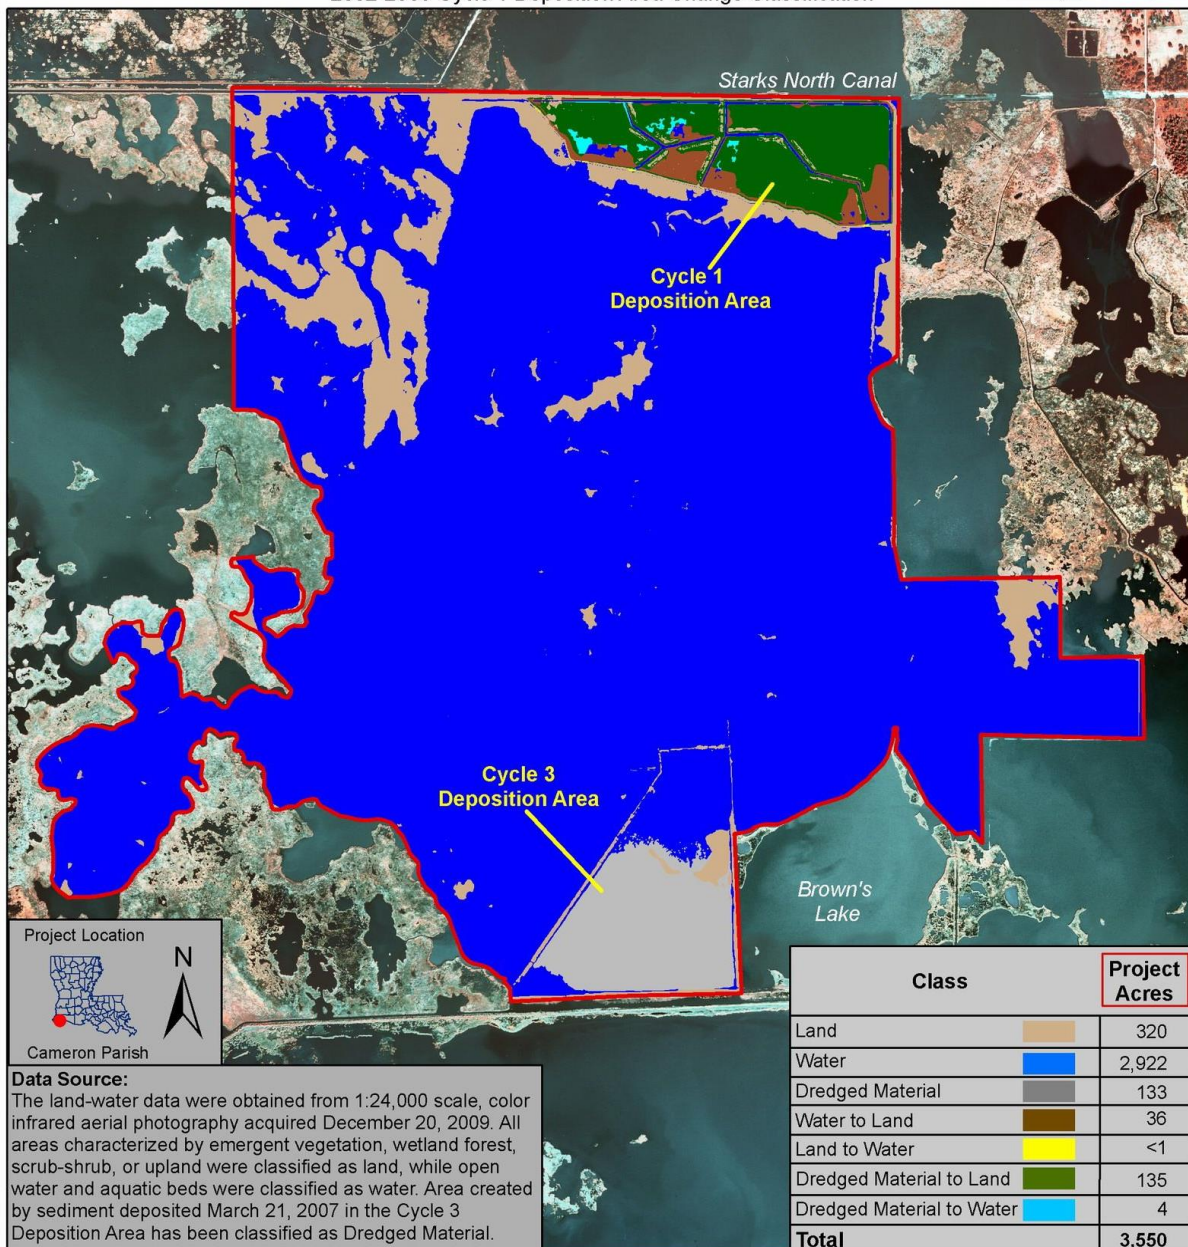
**Figure 2.** Land:Water classification from photography obtained in December 2002 and 2009.

Land/Water photography was captured and analyzed in 2002, 2009 and 2015 (Figures 2 and 3). Due to the CS-28 cycles 3,4 and 5 being constructed after 2002, only the 2009 and 2015 analysis will be used.

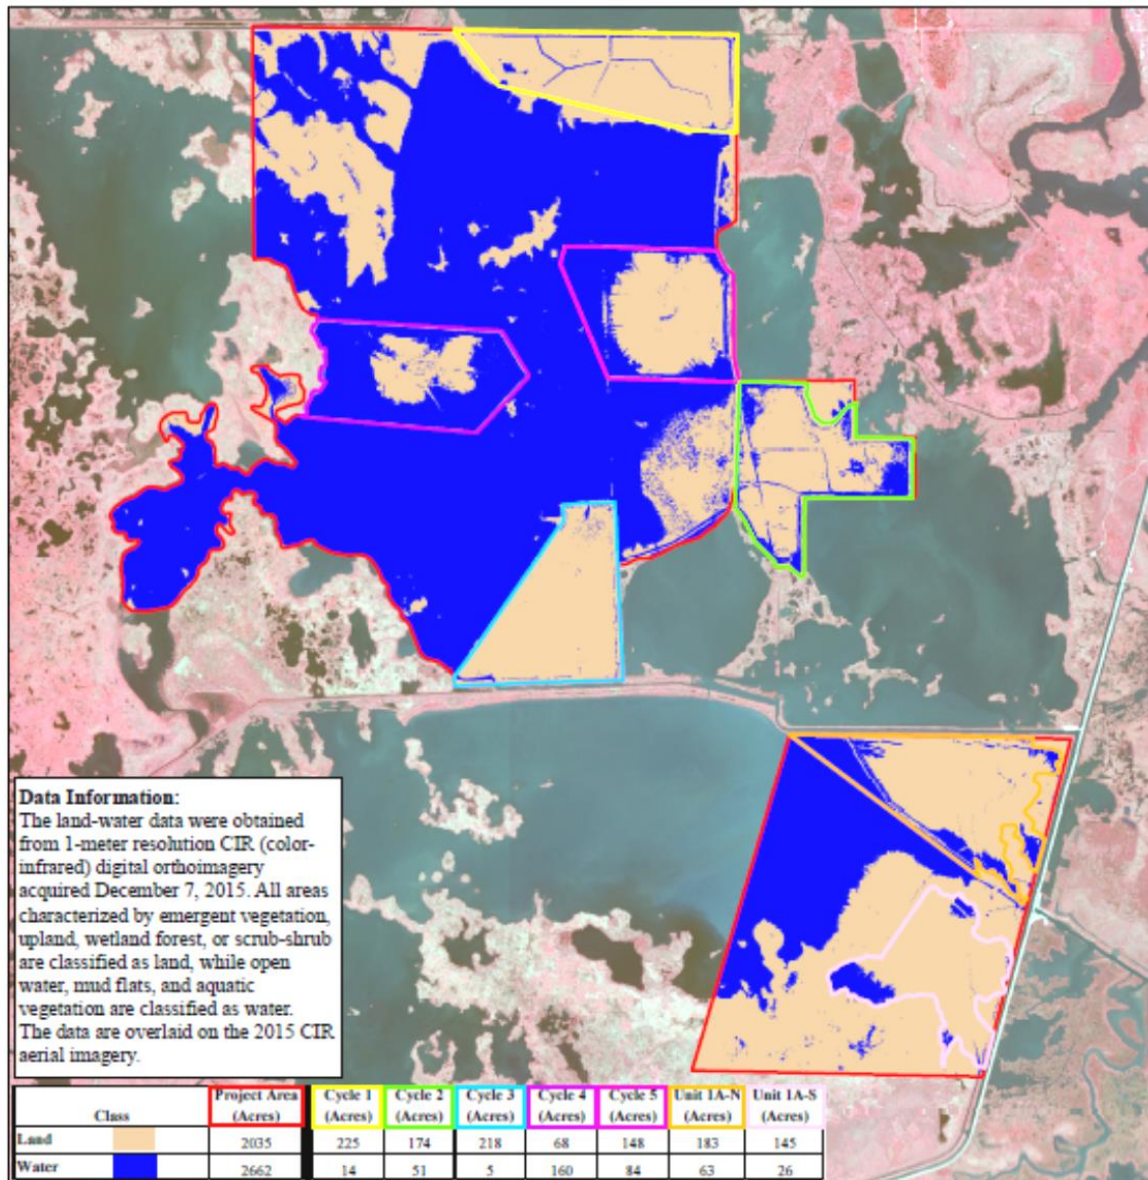
In 2009 the Cycle 3 area contained 132 ac (59.2%) of dredge material and 10 ac (4.5%) of existing land compared to 218 ac (97.8% )of vegetated land in 2015. The northern portion of cycle 3 which was too deep for plant colonization in 2009 had become completely colonized by 2105 which created 86 acres of new vegetated marsh (Figure 3).

Cycle 4 contained 68 ac (29.8%) of land and 160 ac (70.2%) of water in 2015 and Cycle 5 contained 148 ac (63.8%) of land and 84 ac (36.2%) of water. The cycle 4 area has settled to a lower elevation than cycles 3 and 5 (Figure 10) and is mostly water along the South, East and Western perimeters of the cell (Figure3). It is anticipated that the area will fill in over time just as Cycle 3 area did. The cycle 5 area is mostly water towards the west but is expected to expand westward as vegetation and sediments nourish the area (Figure 3).

**Figure 3.** Land:Water classification from photography obtained in December 2015.

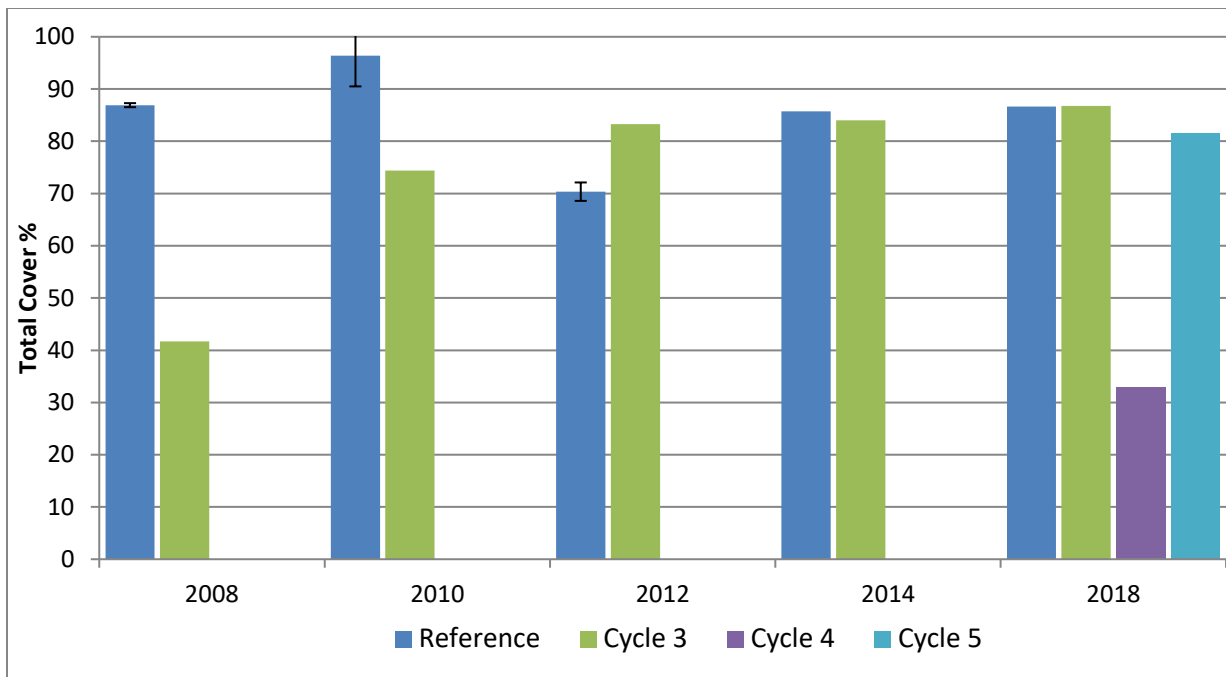
Cycle 3 was constructed in 2007 and had begun to vegetate on the southern end with a 41.6% vegetative cover in 2008 but still had open water areas on the northern end. Vegetation crept northward within the flooded area in 2010 and percent vegetation cover increased to 74.4%. The vegetation cover stabilized around 84.0% in years 2012, 2014 and 2018 which was equal to the percent cover within the reference area (Figure 4). Cycles 4 and 5 were sampled for the first time in 2018. Cycles 4 and 5 had 32.8% and 81.4% cover respectively. Cycle 4 has a higher elevation in the middle of the disposal site which is less flooded and more suitable to vegetative growth, and a lower more flooded elevation around the East, West and Southern edges. The lower flooded areas are likely causing the decrease in percent cover of vegetation. Cycle 5 has a higher more tidal elevation throughout most of its eastern cell, causing a higher percent cover in vegetation species (Figure 4).

**Figure 4.** Total percent cover of emergent vegetation by years within CS-28 cycles 3, 4, 5 and reference area. Mean  $\pm$  SE.

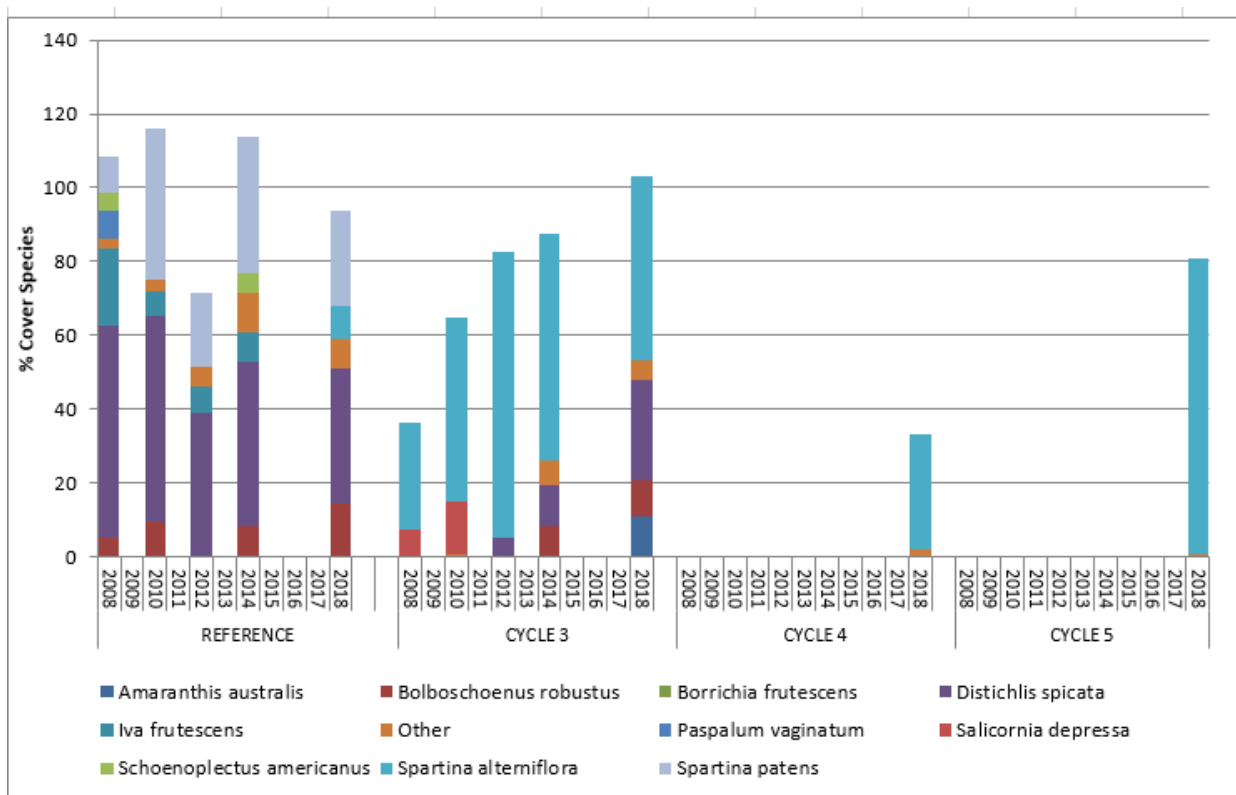
The species assemblage in Cycle 3 during 2008 (3 years after construction) was very similar to the initial species found within Cycles 4-5 during 2018 (3 years after construction). Cycles 3, 4 and 5 were essentially a monoculture of *S. alterniflora* after initial pumping although Cycle 3 had some stands of *Salicornia depressa* until 2010. (Figure 5). The assumption that the Cycles would vegetate from seed appears to have been correct. No plantings have been installed within Cycles 4-5. Currently Cycle 3 has the most diverse plant community with 4 species but it is lacking the presence of *Spartina patens*. Cycles 4 and 5 contain only *Spartina alterniflora* as of now (Figure 5). It will take a long time for the dredged cycles to be as diverse as the reference area, but it will be interesting to see whether the natural community that develops in the older Cycles will eventually mirror the vegetative community present in the existing reference marsh.

**Figure 5.** Percent cover of individual vegetation species by years within CS-28 cycles 3, 4, 5 and reference area

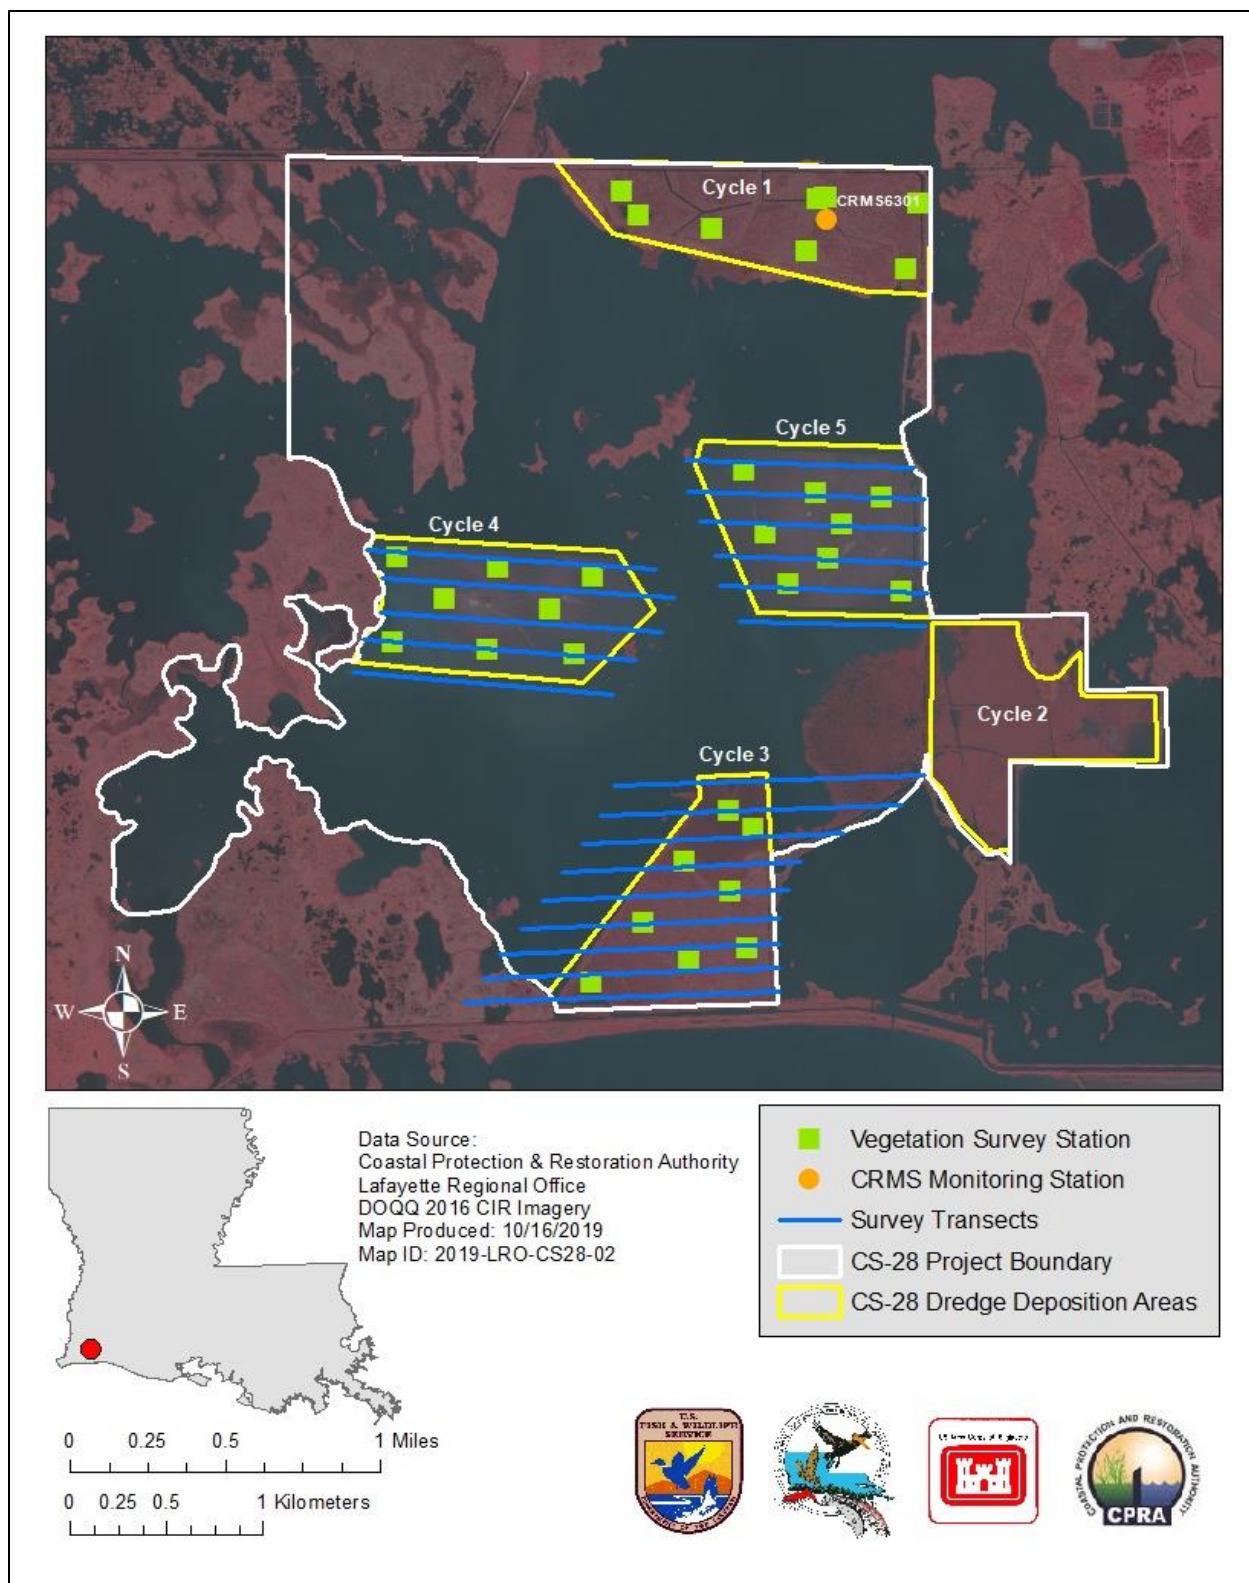
The goal for each of the cycles was a settled marsh elevation of 2.5 ft MLG (.29 ft NAVD88 (Geoid 12A)) after 5 years (Figure 6). Elevations were taken along 9 transects within Cycle 3 in 2013 and 2018 and along 5 transects within cycles 4 and 5 in 2018 (Figures 7-9). Elevation data was collected in NAVD 88 (Geoid 12A) to compare across years.

**Figure 6.** Survey transects, vegetation monitoring stations and project area boundary of the Cycle 3,4 and 5 deposition ares.

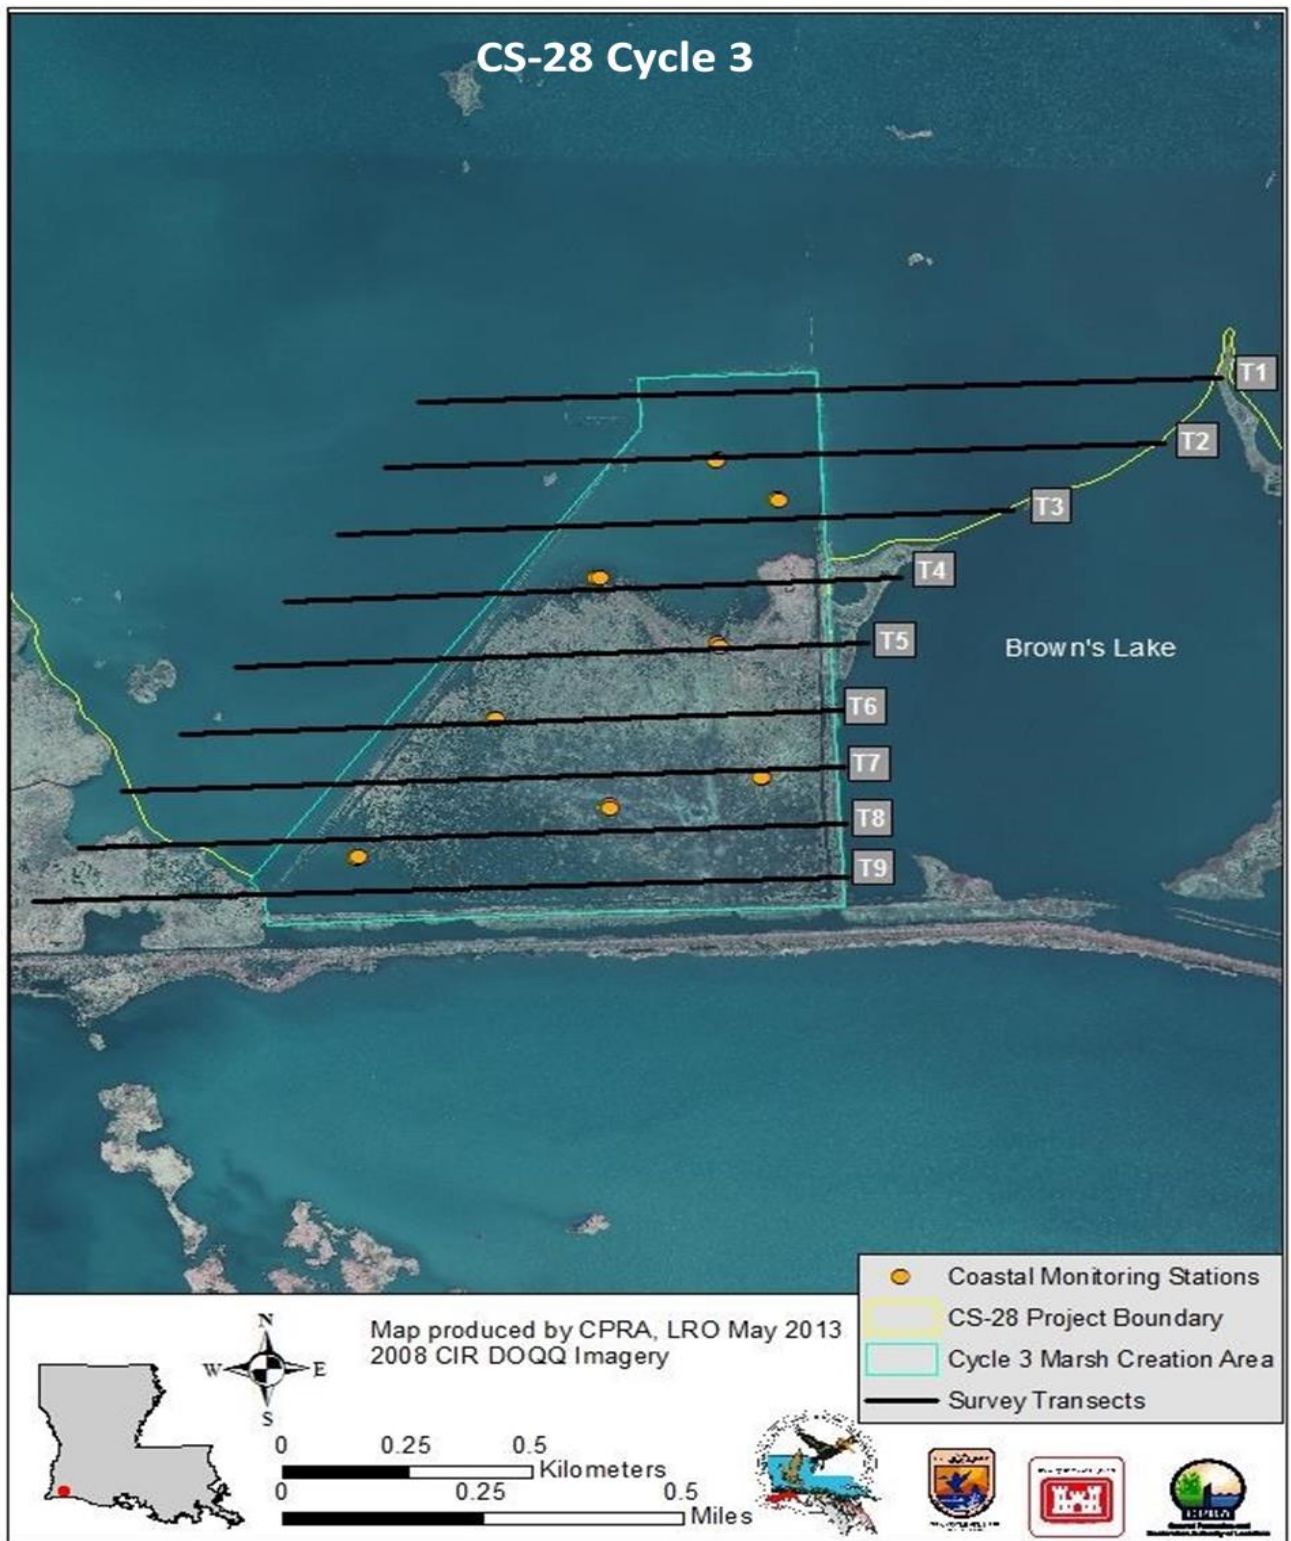
Cycle 3 was measured to be between -2.03 and .80 NAVD 88 (Geoid 12A) in the 2013 survey at year 6 (Figure 10). The Cycle 3 area is below the target elevation in the northern 3 of 9 transects (T1, T2 and T3) surveyed in 2013 (Figures 7 and 10). The low elevations are linked to the shallow, unvegetated open water areas in the northern end of the project area.

**Figure 7.** Survey transects, vegetation monitoring stations and marsh creation boundary of the Cycle 3 deposition area in 2008.

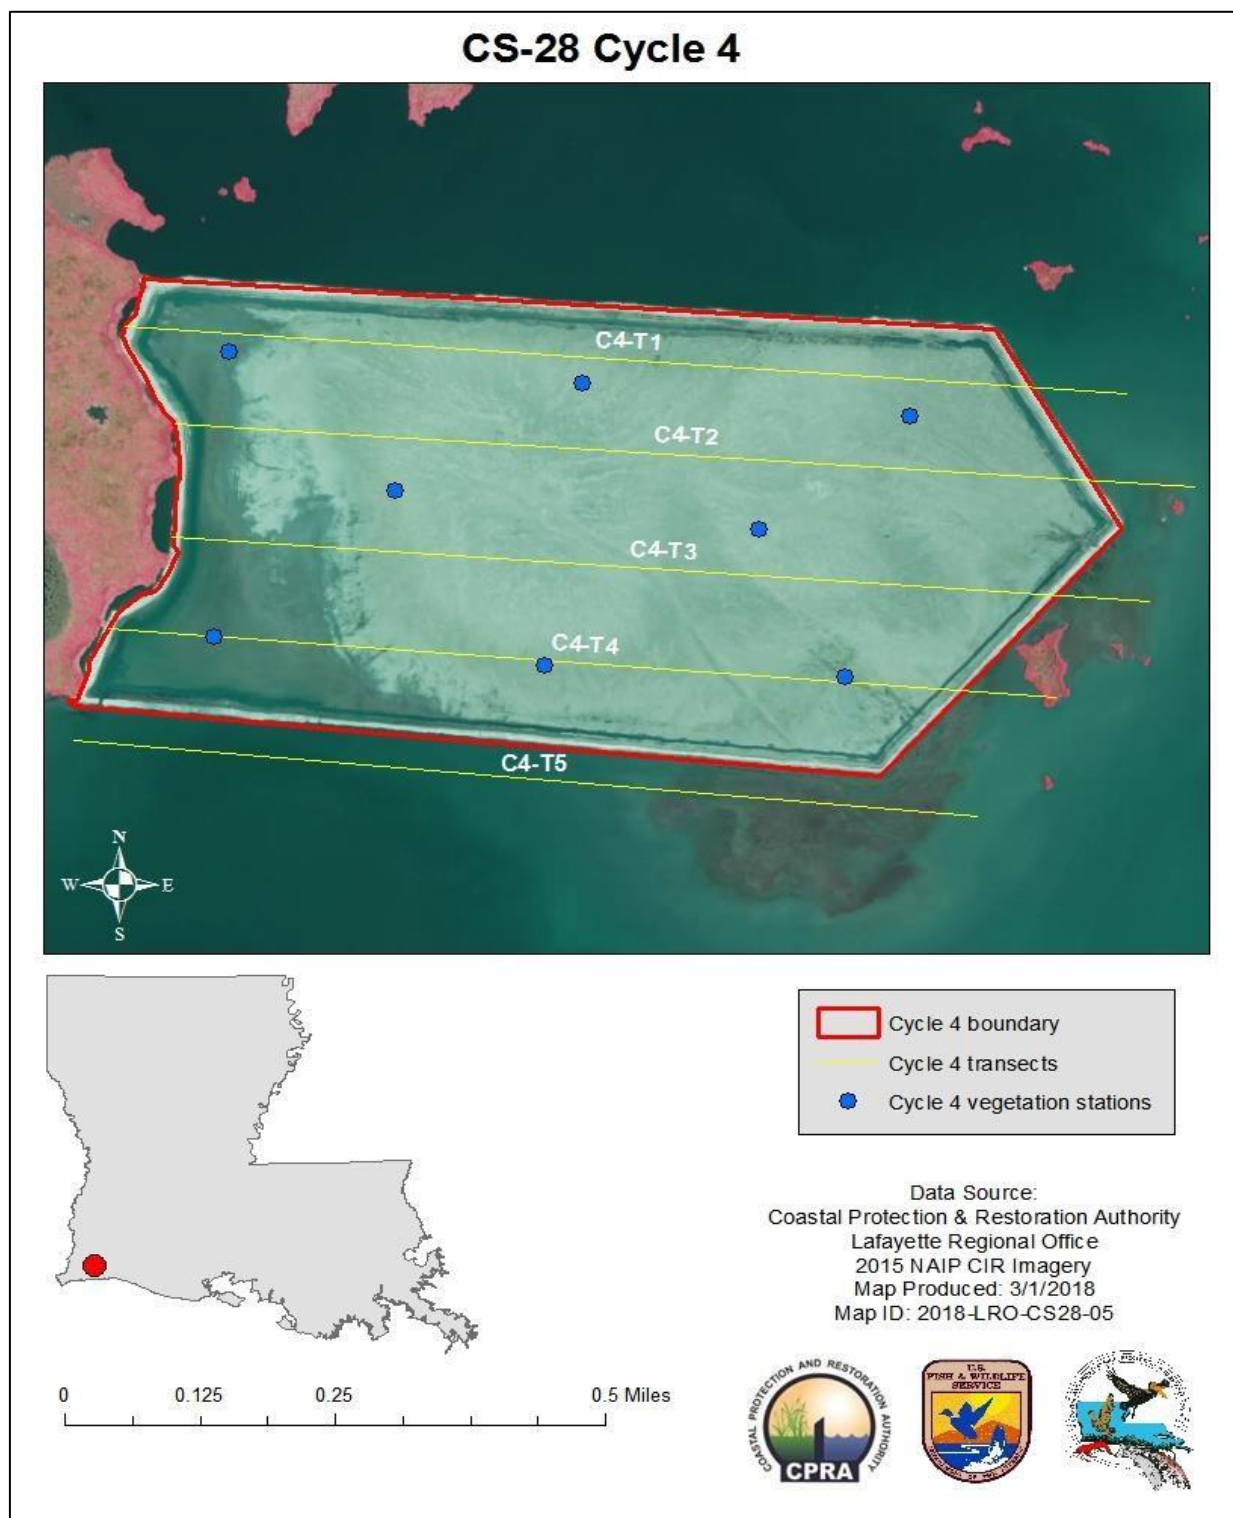
**Figure 8.** Survey transects, vegetation monitoring stations and marsh creation boundary of the Cycle 4 deposition area in 2015.

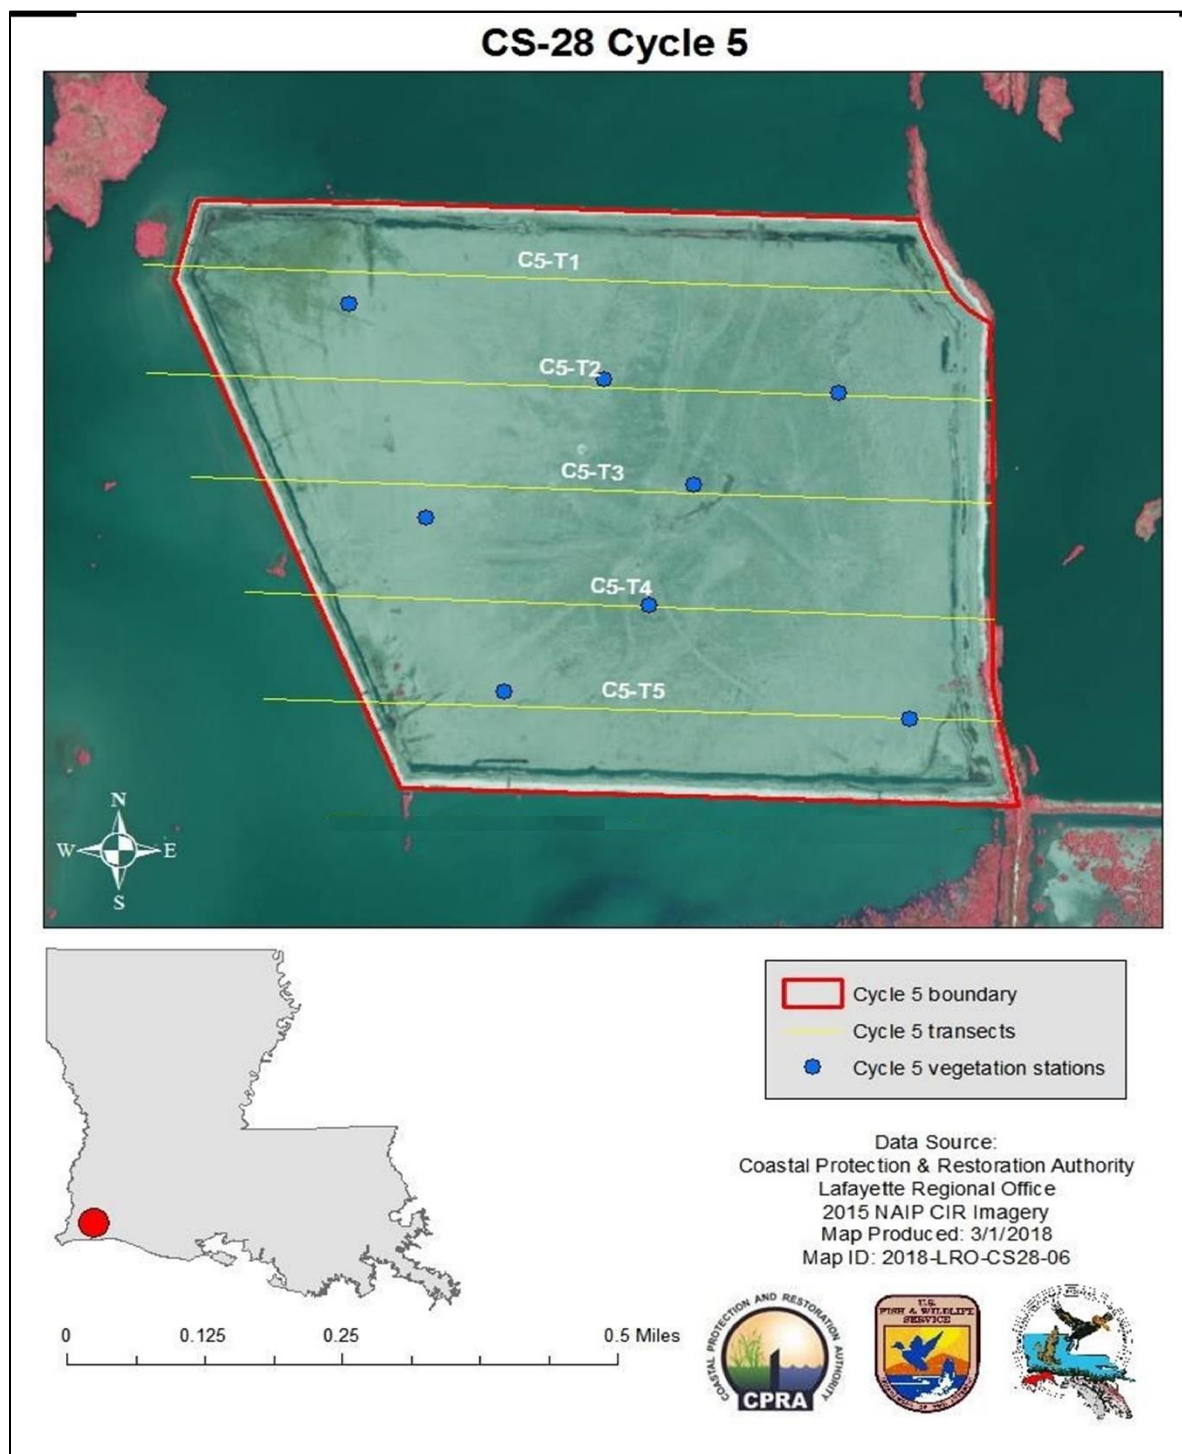
**Figure 9.** Survey transects, vegetation monitoring stations and marsh creation boundary of the Cycle 5 deposition area in 2015.

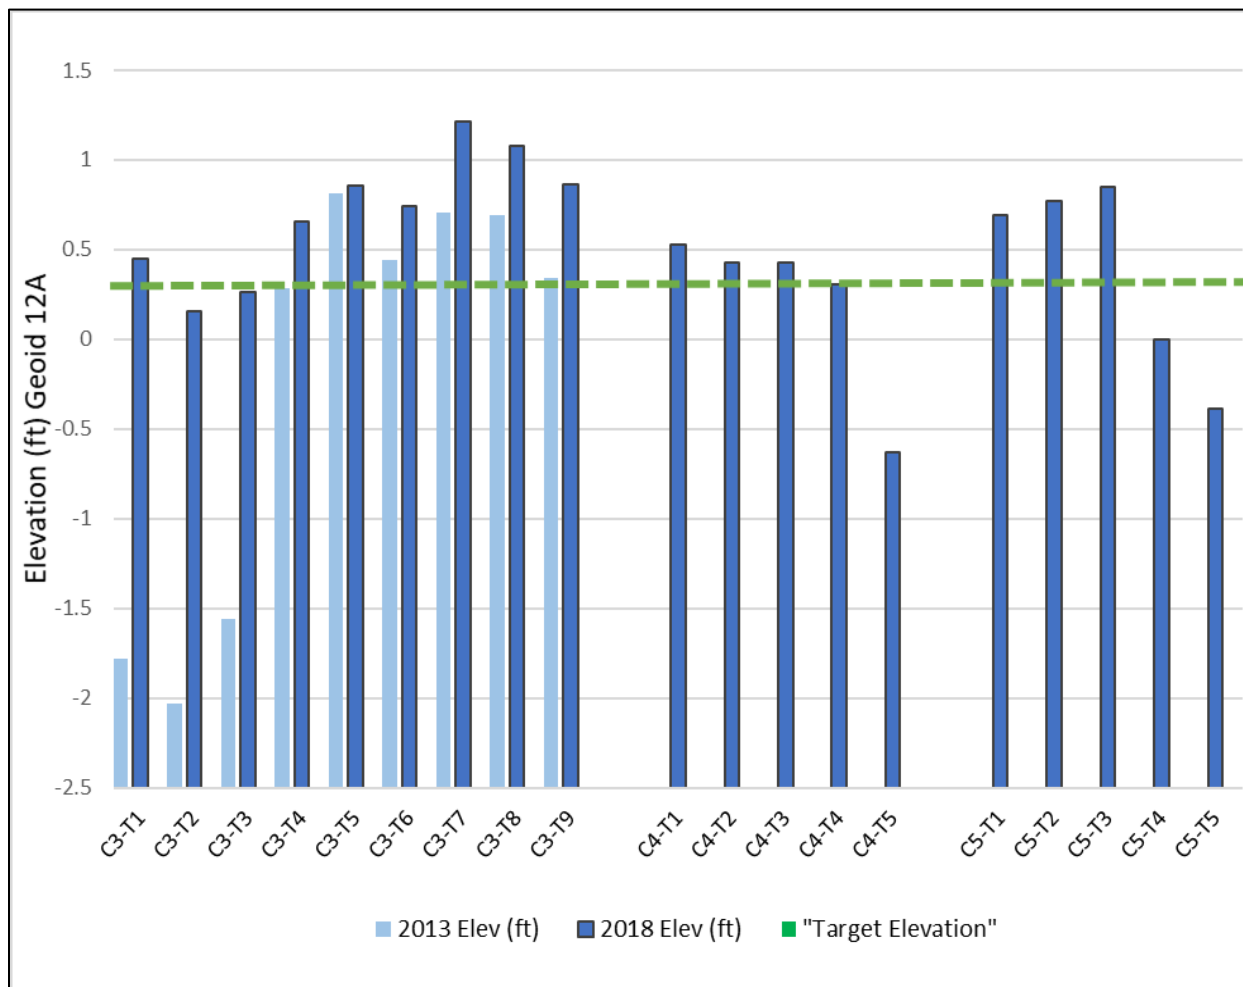
The 2018 survey has shown that Cycle 3 now has only 2 transects (T2, T3) on the northern end that are now slightly below the target elevation (Figure 10). The shallow, unvegetated open water areas have now become mostly vegetated with a higher elevation which can be seen in the 2015 land-water classification (Figure 3) and elevation survey (Figure 10).

The cycle 4 and 5 surveys were taken at year 3 after completion. The Cycle 4 cell has settled to an elevation of 0.52 (C4-T1) to 0.30 (C4-T4) ft NAVD 88 (Geoid 12A) which is at or above target elevation. The transect C4-T5 was taken outside of the cycle 4 cell to capture overflow benefits and had an elevation of -0.63 ft.

Cycle 5 has settled to an elevation of 0.85 (C5-T3) to -0.39 (C5-T5) ft NAVD 88 (Geoid 12A). The target elevation of 0.29 ft was reached at 3 of the 5 transects. The 3 transects (C5-T1, C5-T2 and C5-T3) had elevations from 0.69 to 0.85 ft and were much higher than target elevations (Figure 10). Additional settlement is expected to occur but it is likely that the cell was pumped to a higher elevation on the northern end. The transects C5-T4 and C5-T5 (Figure 9) had elevations of 0.00 and -0.38 ft respectively (Figure 10). Elevations are expected to increase over time as vegetation migrates southward as was seen in Cycle 3.

**Figure 10.** Survey elevation data and target elevation from 2013 and 2018 for Cycles 3,4 and 5 deposition areas.
